Lambert Substation Outage Response

Ameren Missouri
08.03.2016

The Event – July 3, 2016

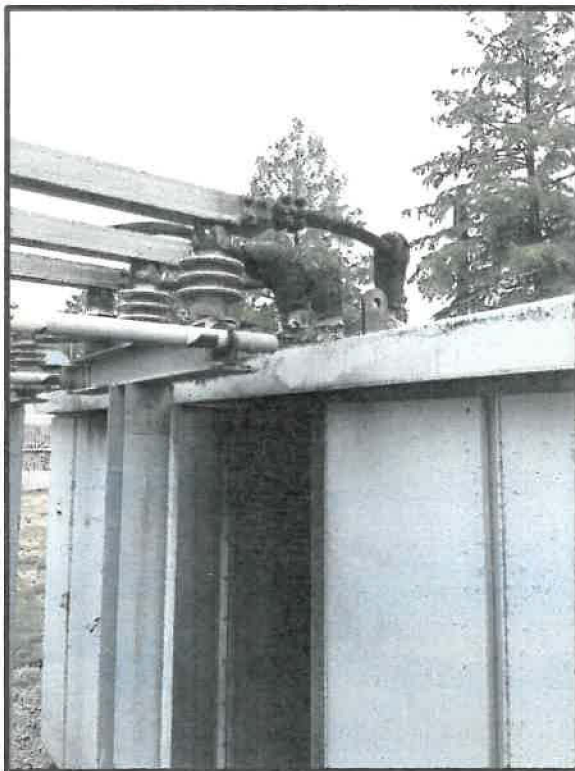
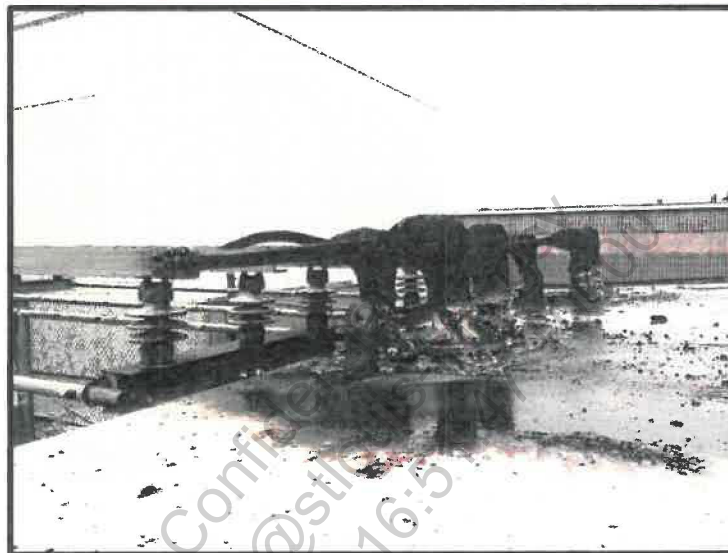
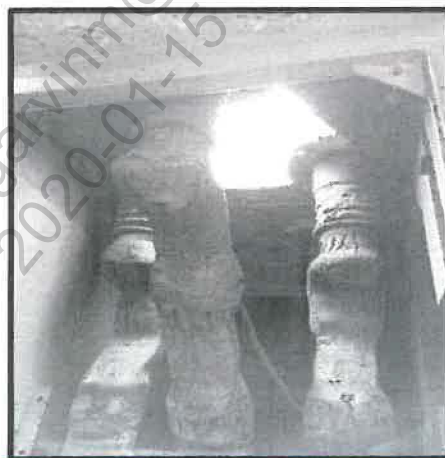
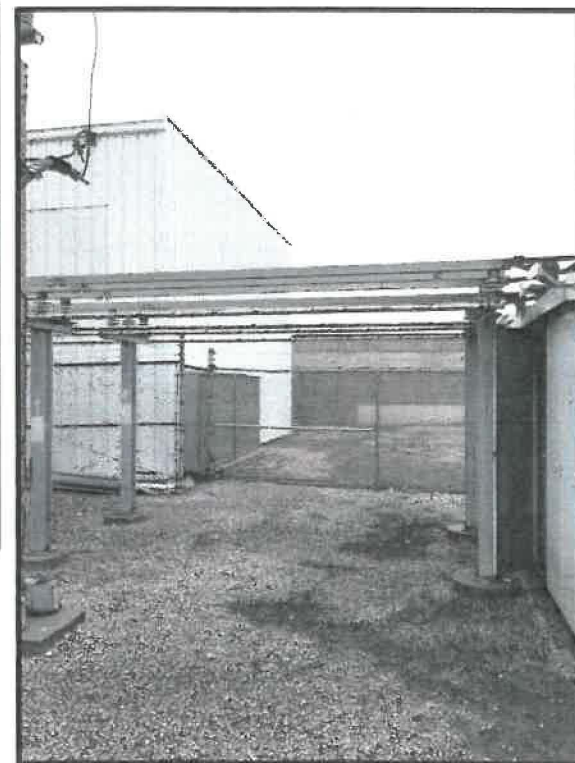
- Circa 1970s substation construction includes open air buswork from transformer to rooftop-bushing switchgear.
- Rooftop bushings flashed over. Likely due to rain seepage at bushings. Extensive switchgear damage occurred when one bushing flashed over and quickly engulfed both sets of bushings.
- Fault currents likely burned open a phase of the 34,000 volt supply conductor near the substation.

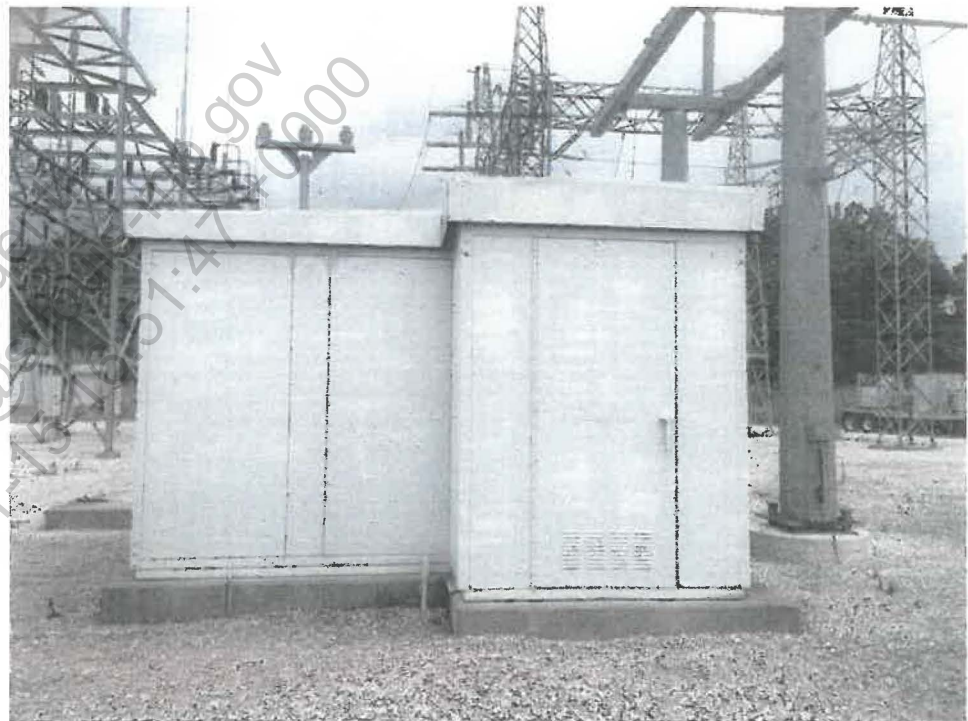
- The switchgear at Lambert is badly damaged
- Replacing with a spare switchgear.
- Spare switchgear does not have rooftop bushings

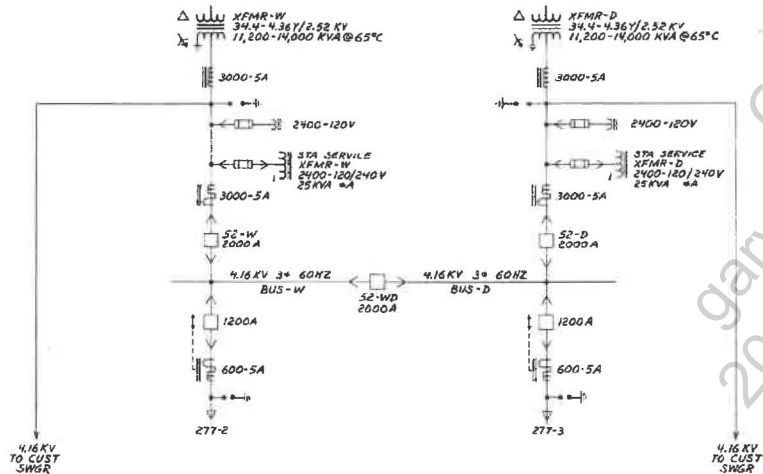
Before

No means for quick isolation from customer

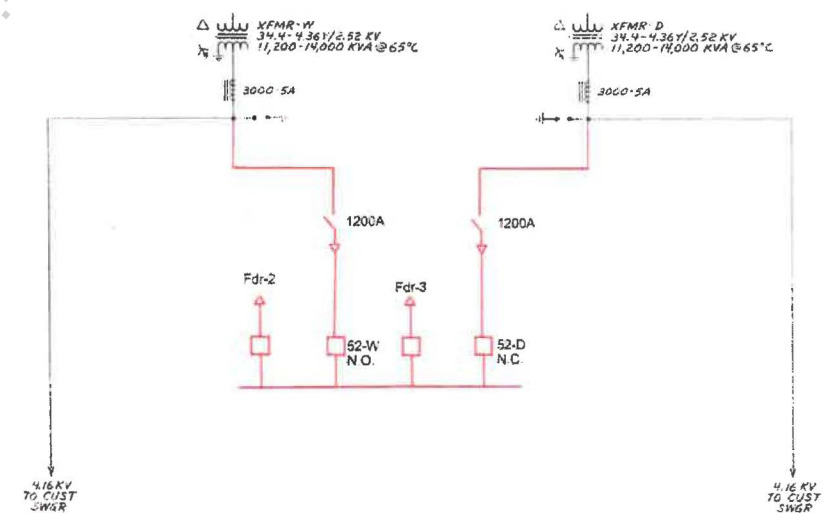
After

Disconnect switches provide means of quick isolation

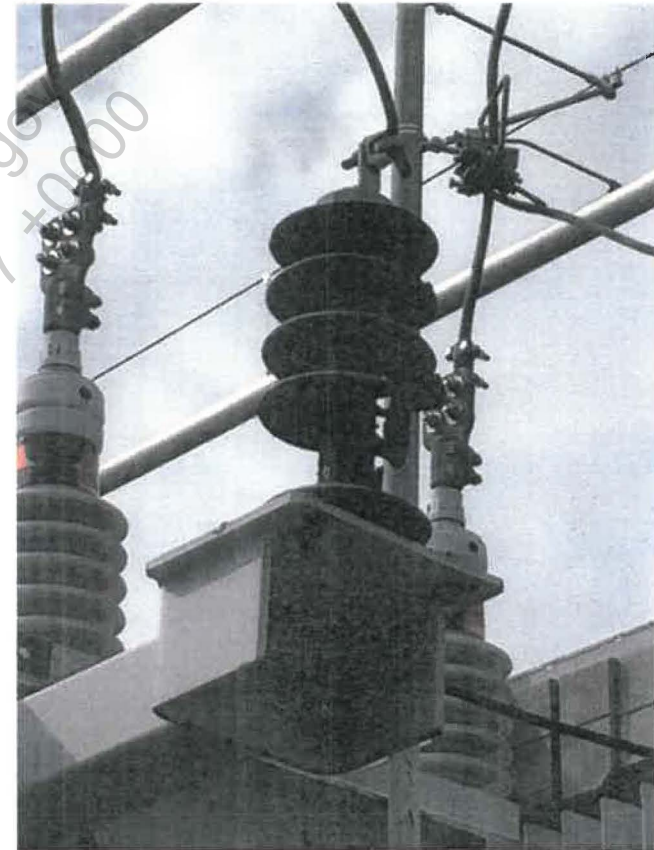
- St Louis International Substation supplies terminal 2 and portions of Concourse C.
- Outage to Bus W due to a failed lightning arrestor on Ameren owned Transformer W.
- Ameren Missouri loads transferred successfully.
- **Repair Action:** All lightning arrestors on Transformer W were replaced
