ST. LOUIS LAMBERT
INTERNATIONAL AIRPORT®

AIRPORT MASTER PLAN

CHAPTER 11 - FACILITY CONDITION ASSESSMENT

FEBRUARY 2023 - FINAL DRAFT

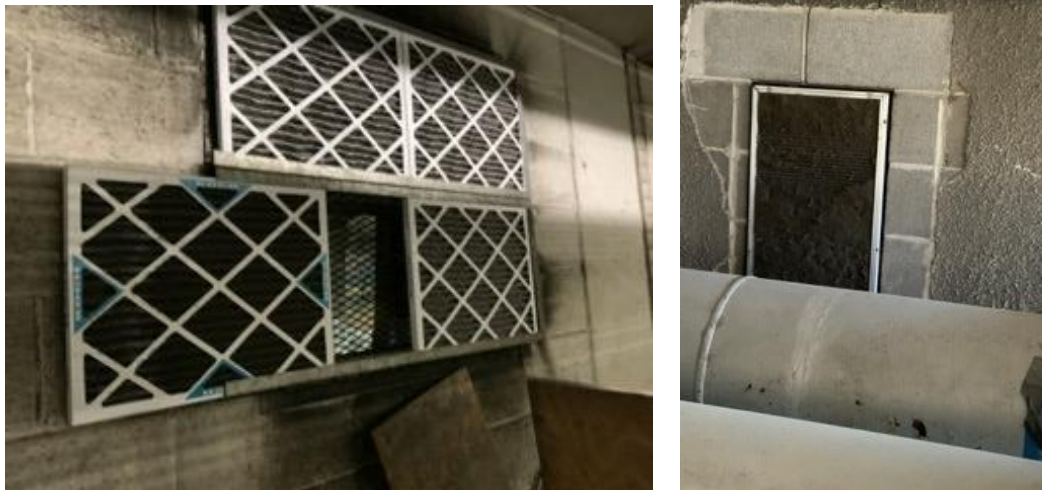
On the apron level, some bird screens and filters on air intake louvers and bird screens on exhaust louvers from service areas are heavily coated with dirt and debris, as illustrated in **Figure 11.2-3**. Some bird screens

on outside walls and opening into baggage handling and similar service areas are almost completely obstructed, inhibiting airflow.

Figure 11.2-3: Fouled Air Filters Inhibiting Air Flow

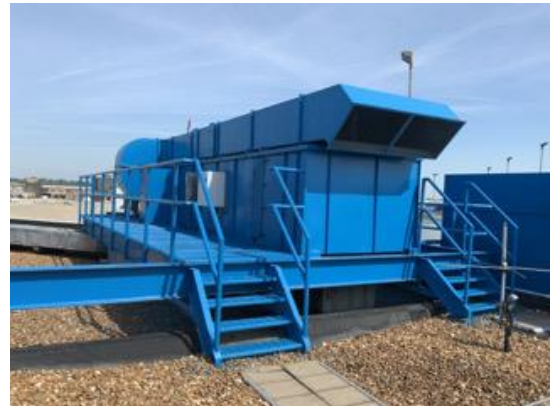
Most air distribution in Terminal 1 is from indoor air handling equipment, but some is from rooftop units (RTU). The RTU serving the Airport Properties Department is in poor condition. Among other mechanical issues, the piping cabinet enclosure is made of plywood and sheet metal and is deteriorating. The lack of appropriate insulation and weather resistance causes the condensate line to freeze, and occasional leaks in the office area below. The RTU serving the Lindbergh Conference Room reportedly has inadequate capacity to adequately cool and dehumidify the large conference room.

Figure 11.2-4: Rooftop Air Conditioner AHU148 Serving Properties Division

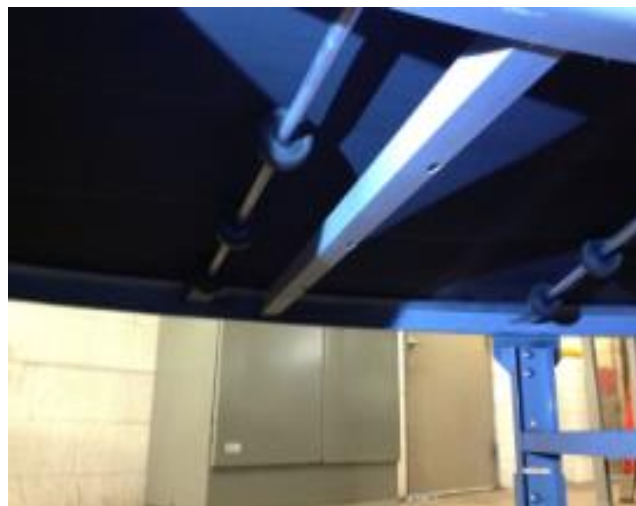
Many of the components, both electrical and mechanical, are in good condition. Most of the system is functioning as intended and only a few issues are noted. Motors, reducers, Programmable Logic Controllers (PLCs), cables, photocells, and control stations looked in good condition for the majority of T1. There are common minor issues that were noted throughout the T1 system. Most of these are standard industry items that exist throughout other BHS systems across the country. Bearing caps, under carriage covers, ripped belt splicing, belt tears, and trim damage are some of the items noted during our assessment as shown in **Figure 11.2-7** and **Figure 11.2-8**.

Figure 11.2-7: T1 Power Turn

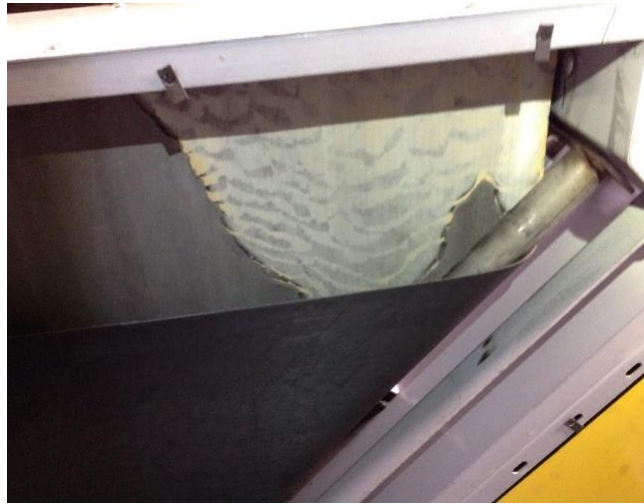
Figure 11.2-8: T1 Merge 45

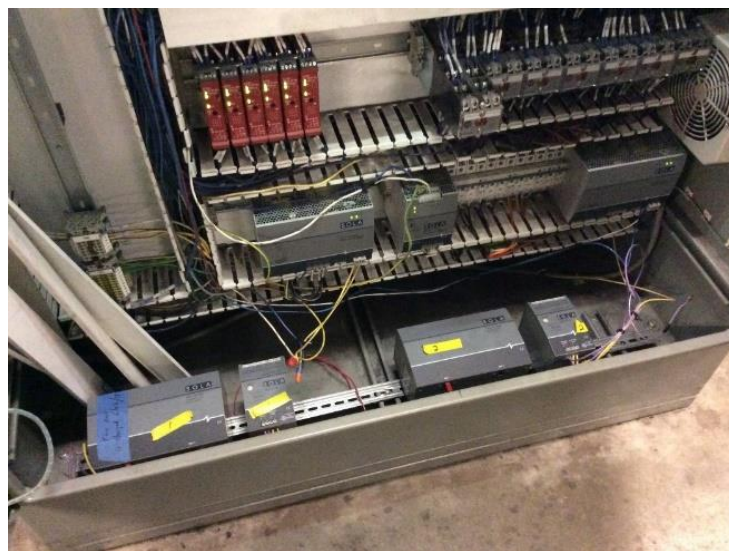
Figure 11.2-9: MDP2-T1 Panel

Two more notable issues in T1 should be addressed immediately. A number of the MCPs have loose wires that do not appear to be terminated properly. In addition, panduit covers are laying in the bottom and have not been replaced as shown in **Figure 11.2-9**. STLAA attempted to install uninterrupted power supply (UPS) systems in the MCPs, but that effort was not completed and was left as-is. Secondly, the make-up unit, MU1, in the far west corner is a concern. The sound indicates the drive chain is slipping or catching creating a very loud jolt on the motor and reducer. In addition, there was no functioning safety alarm required by industry standard specifications. Finally, a damaged trim piece on the unit is a hazardous condition that could injure an appendage or damage loose clothing, as illustrated in **Figure 11.2-10**.

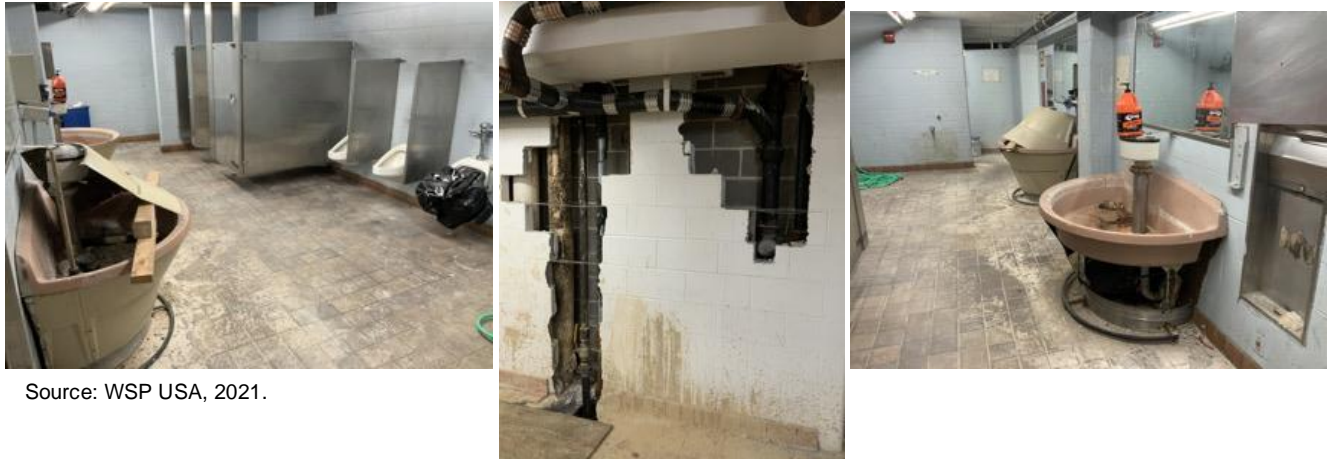
Figure 11.2-16: Concourse C - Apron Level Plumbing Fixtures

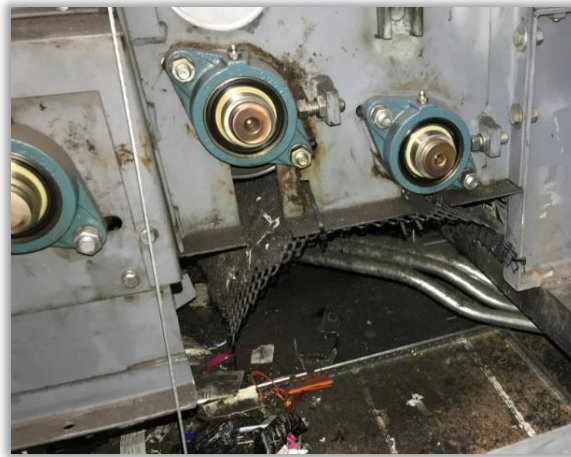
Figure 11.2-19: T2 Transport Conveyor – Missing Bearing Caps

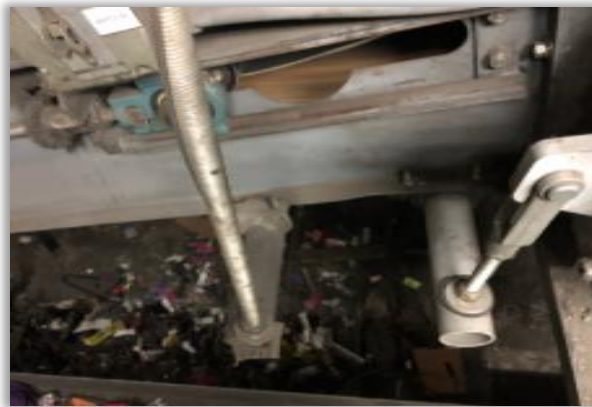
Figure 11.2-21: T2 Decline Conveyor – Safety Guard Missing

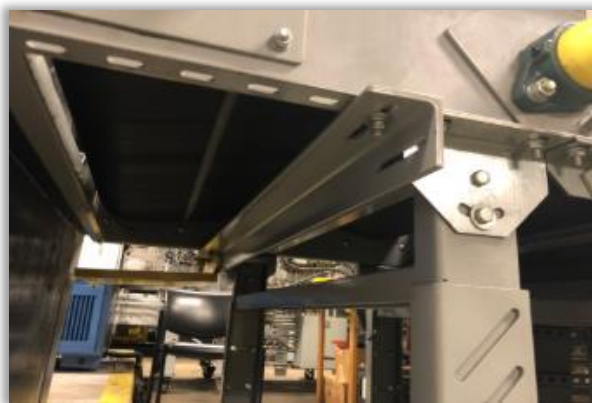
Figure 11.2-22: T2 Transport Conveyor – Belly Cover Missing

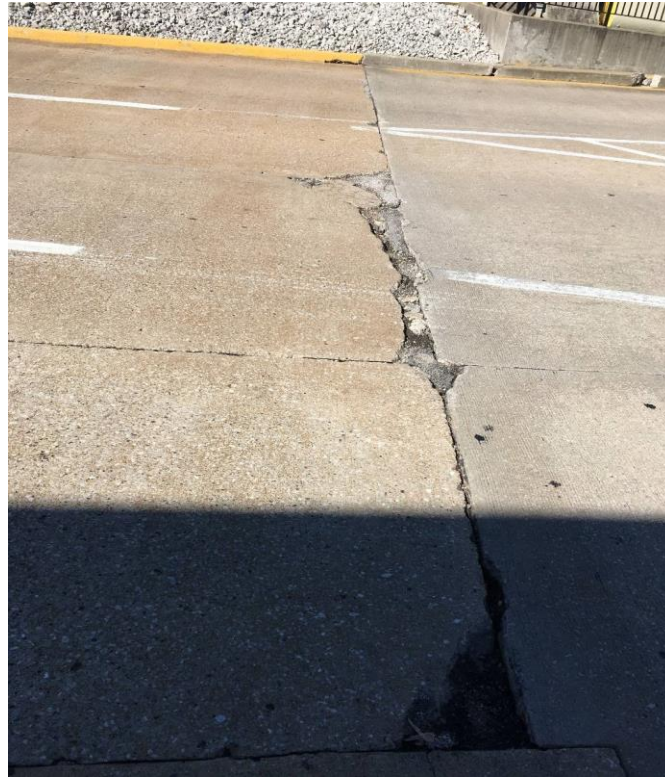
The entrance roadway ramps, Ramps B, C, and E, are in a similar state of deterioration and exhibit the following conditions. Pavement cracks are visible throughout, with the pavement and/or curbs and curb inlets exhibiting deterioration at several locations, as shown in **Figure 11.2-29**. The paint on the curbs is worn or scraped off at numerous locations. The pavers immediately behind the curb, which were originally intended as salt spray protection, exhibit settlement or are missing, allowing soil and debris to accumulate behind the curbs. These pavers are undermined in several places and are noticeably uneven. There are also several signs which have been damaged by traffic and/or are non-reflective.

Figure 11.2-29: Arrivals Drive – Deteriorated Pavement and Curb

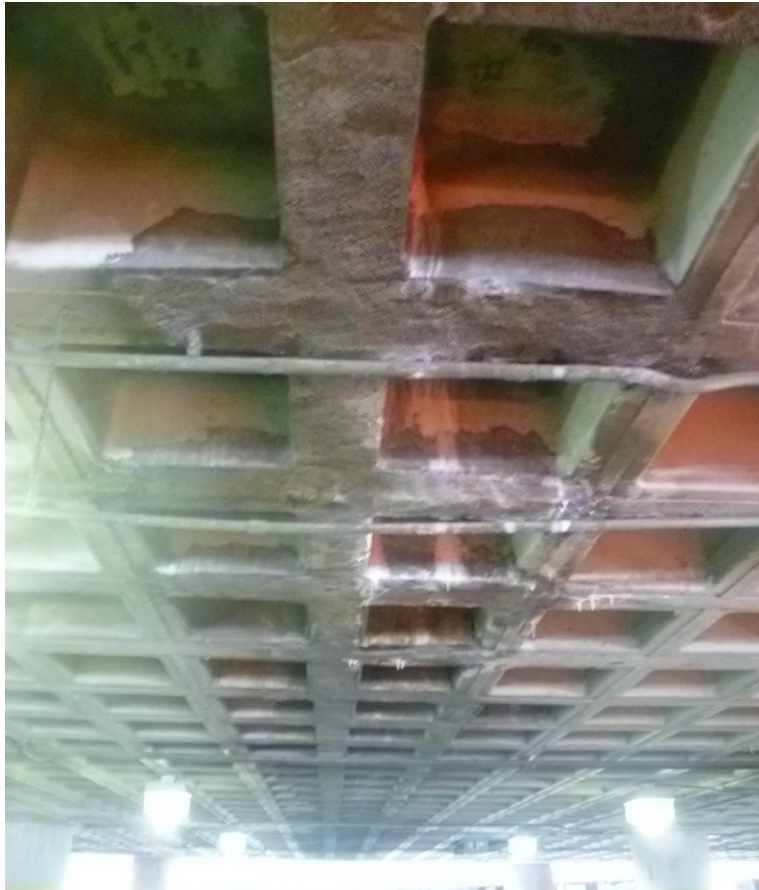
Figure 11.2-30: Arrivals Drive Bridge Slab (underside) showing previous patches and efflorescence

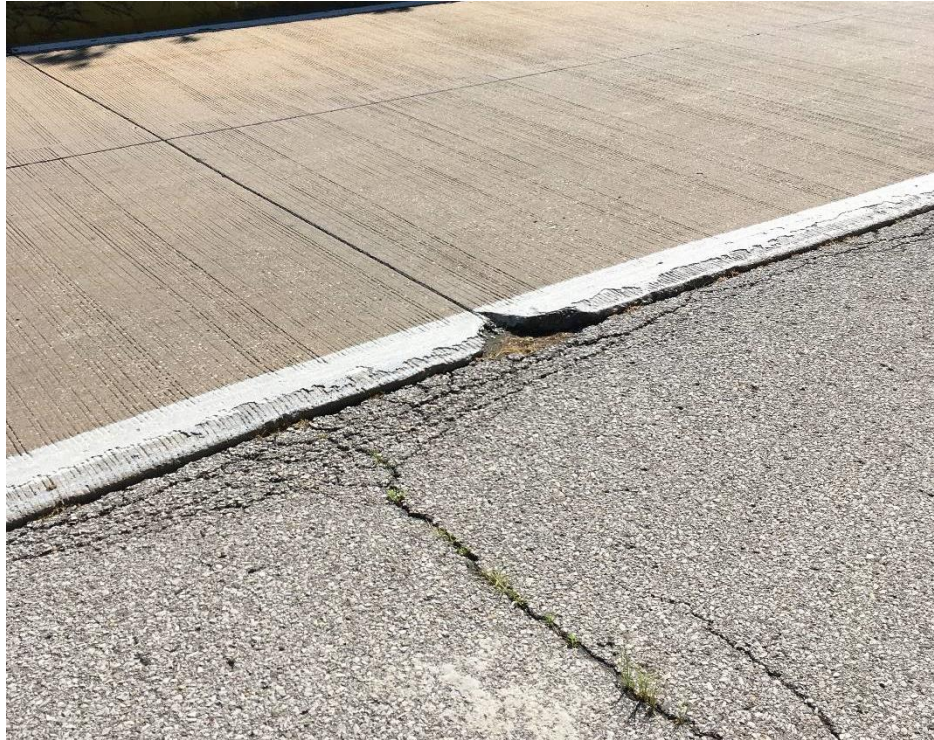
Figure 11.2-31: Pavement and shoulder deterioration typical of Ramps A and D approaches

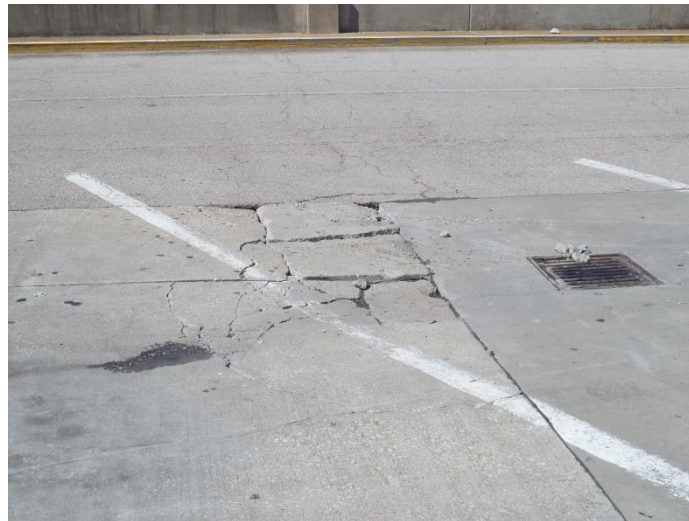
Figure 11.2-32: Departures Drive showing deteriorated driving surface

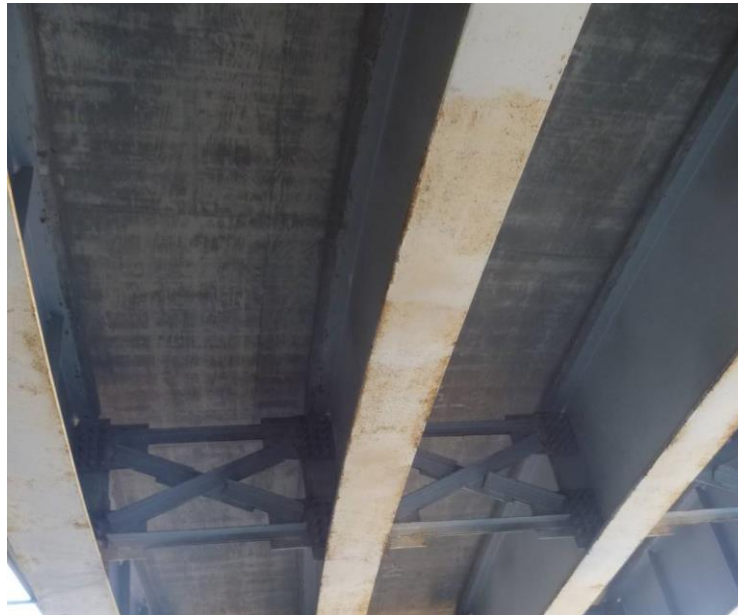
Figure 11.2-33: Bottom of Ramp D girders showing deterioration of paint

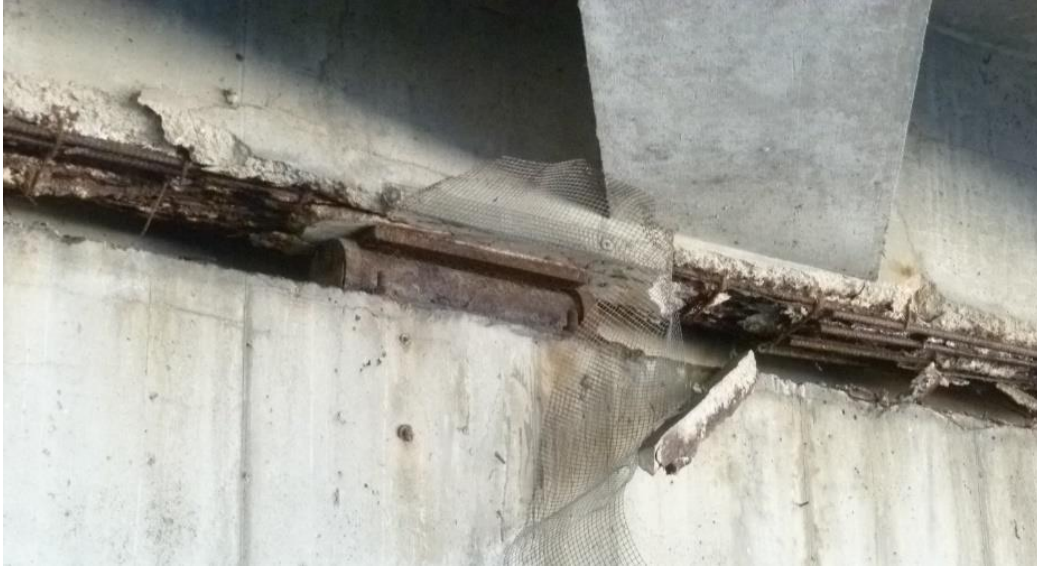
Figure 11.2-34: Departures Drive over Arrivals Drive Bridge southwest end beam showing deteriorated concrete, exposed rebar, and rusted bearings

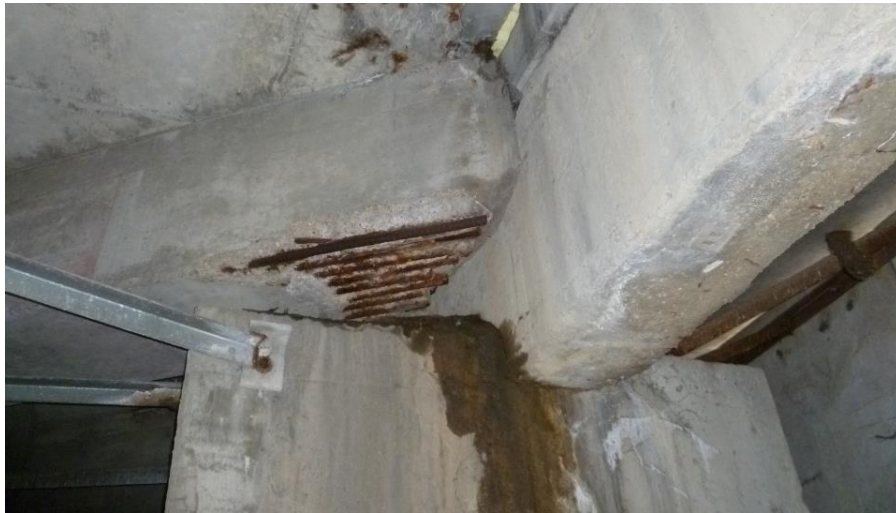
Figure 11.2-35: Departures Drive over Arrivals Drive Bridge – Deteriorated beam ends and water leakage within area enclosed by fascia panels

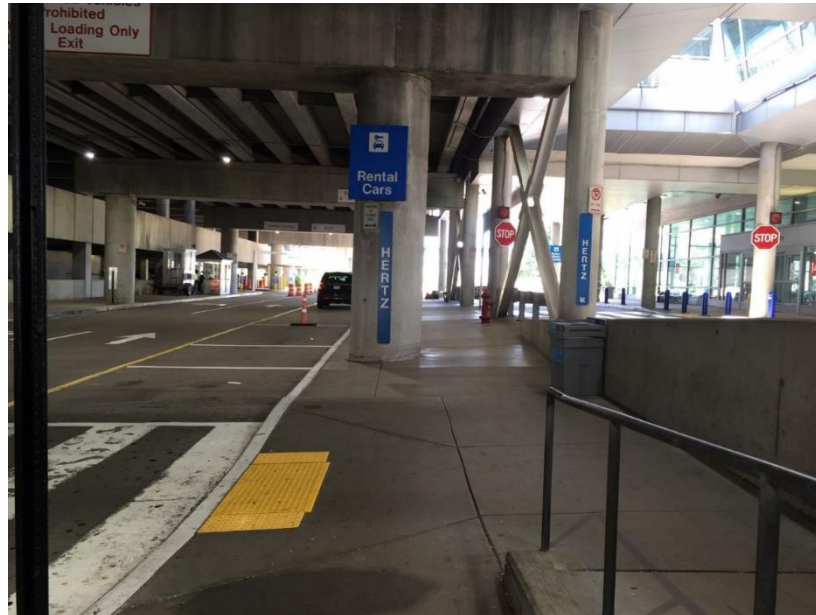
Figure 11.2-36: Non-reflective signage and worn pavement markings on Arrivals Drive

The Arrivals Drive Roadway consists of a concrete pavement section which is in generally good condition. The curbs are scuffed/damaged in a few places. The salt spray guard pavers exhibit settlement in several locations which has created a small step between the pavers and the curb. The pavement markings, both roadway striping and crosswalks, are fading in several locations as well as shown in **Figure 11.2-36**.

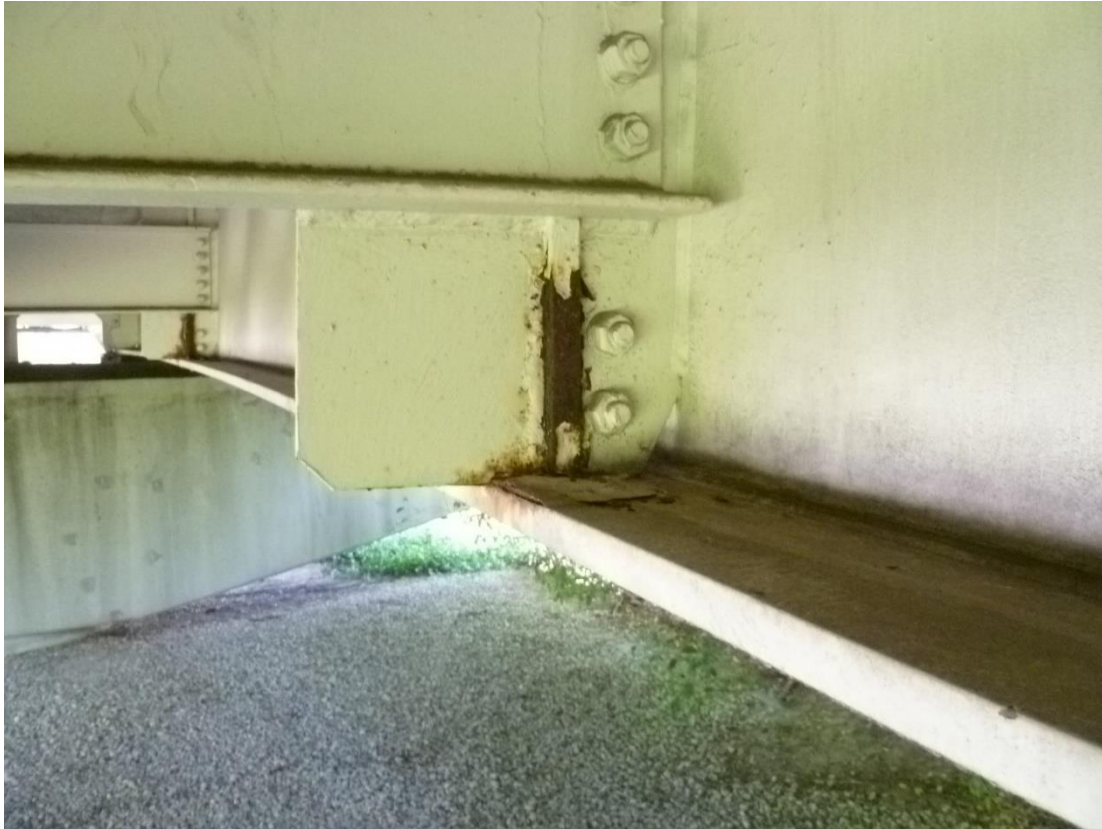
Figure 11.2-37: Rusted intermediate diaphragm connector plate on Departures Drive Bridge

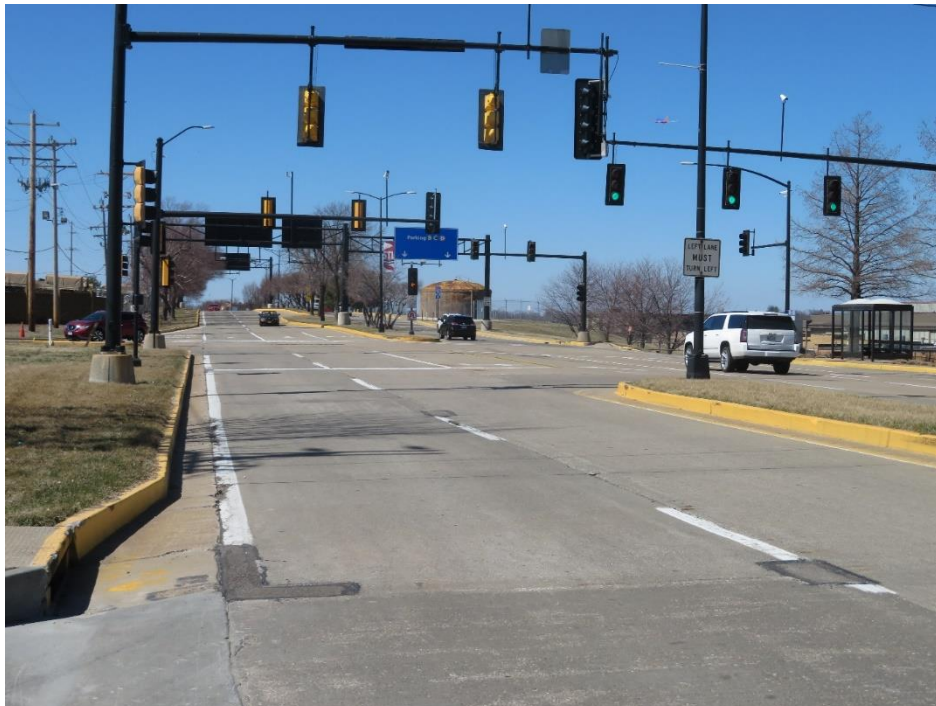
Figure 11.2-38: LIB showing typical pavement patching and worn curbs

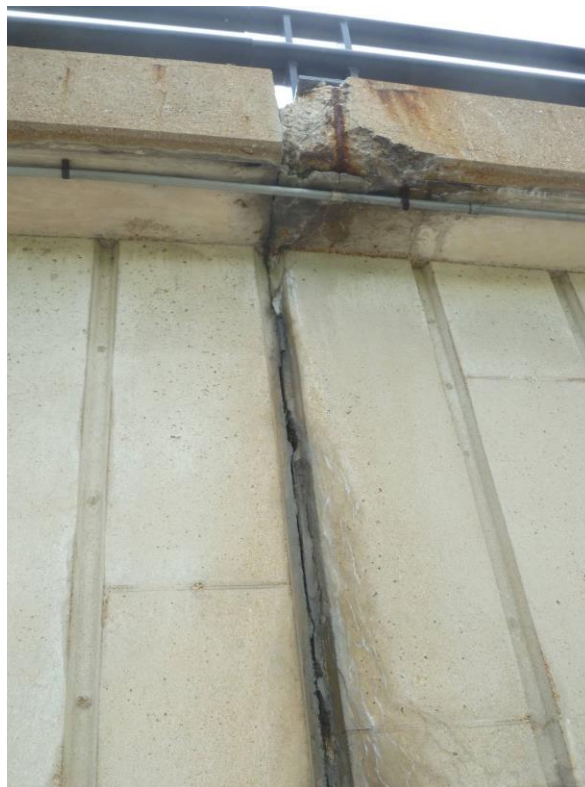
Figure 11.2-39: LIB over Airflight Drive Bridge approach retaining wall joint and barrier curb showing significant deterioration

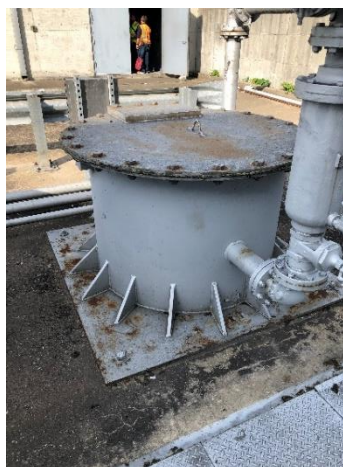
The above grade pump housings and piping are experiencing corrosion and will require sandblasting and recoating to maximize the life of these components. The pump housing gaskets, illustrated in **Figure 11.2-43**, require replacement. The maintenance service provider for the pump station stated valves were operational with no sticking.

Figure 11.2-43: Example of a Primary Stormwater Pump Housing and Valve

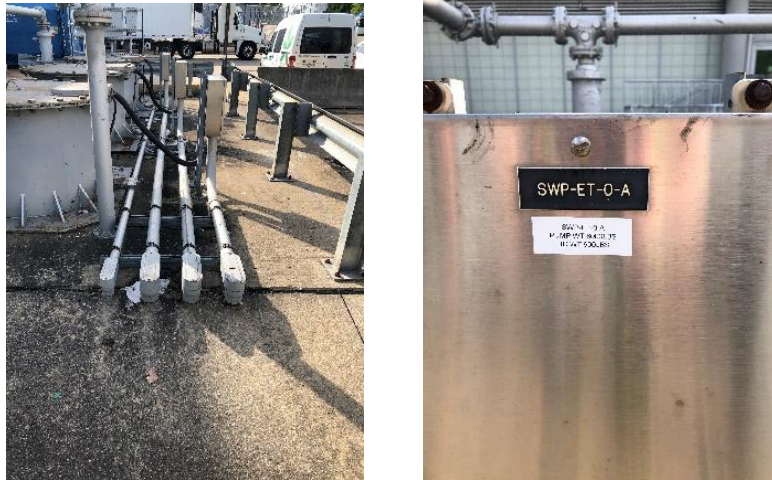
The control panels and above grade electrical controls system conduits shown in **Figure 11.2-44** are in good condition. Electrical connections and amp draw are being checked every year.
