Lambert Substation Outage Response

Ameren Missouri
08.03.2016

The Event – July 3, 2016

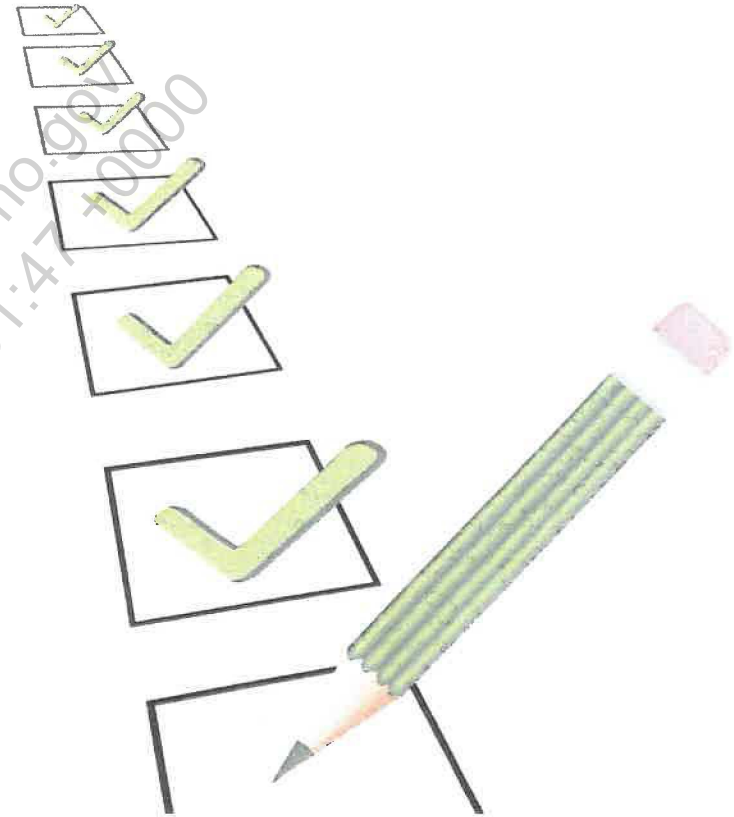
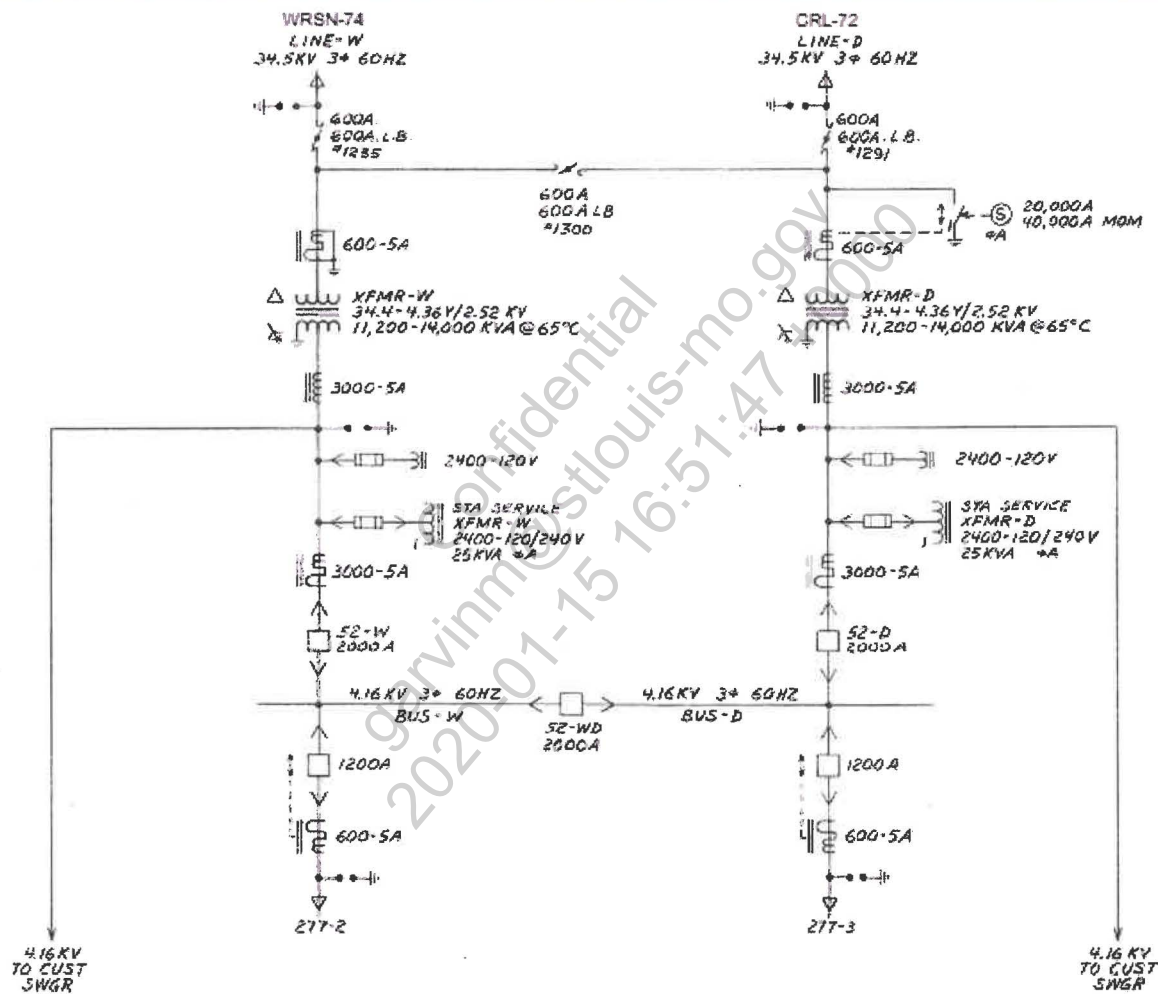
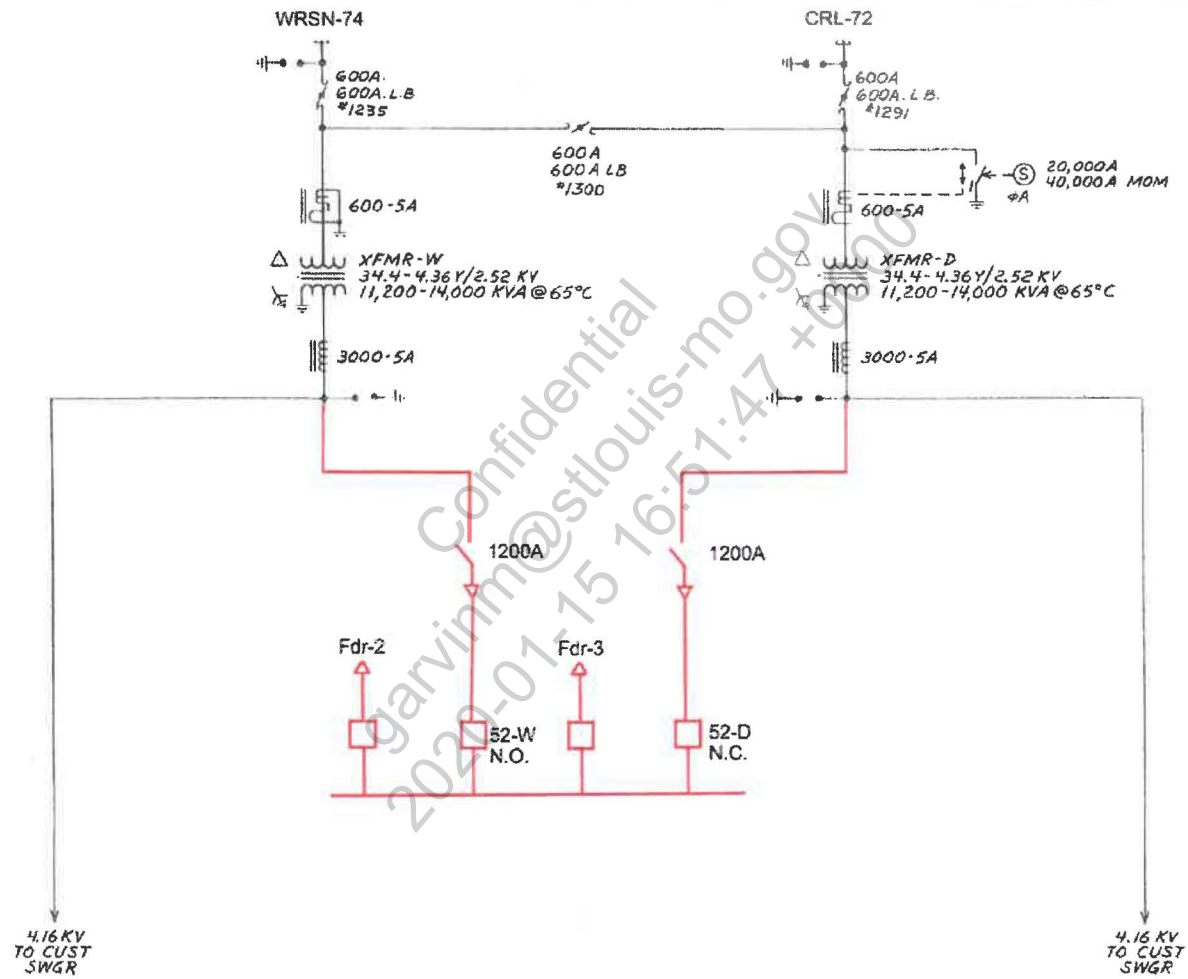
July 17 Outage

- St Louis International Substation supplies terminal 2 and portions of Concourse C.
- Outage to Bus W due to a failed lightning arrestor on Ameren owned Transformer W.
- Ameren Missouri loads transferred successfully.
- **Repair Action:** All lightning arrestors on Transformer W were replaced
