ST. LOUIS LAMBERT
INTERNATIONAL AIRPORT®

AIRPORT MASTER PLAN

CHAPTER 11 - FACILITY CONDITION ASSESSMENT

FEBRUARY 2023 - FINAL DRAFT

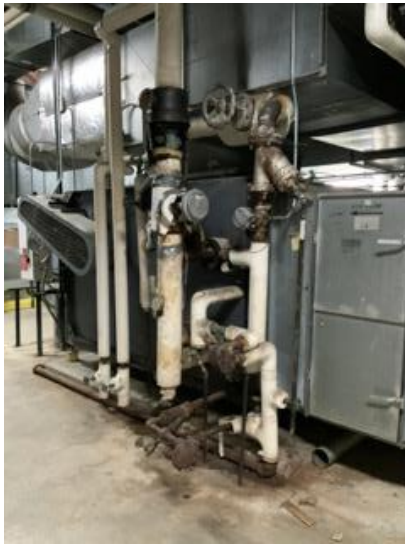
Figure 11.2-1: Typical Air Handler Coil Piping Connections

Air distribution systems are generally in good condition. With proper humidity control in the distributed air supply, duct systems can continue in use with only periodic cleaning. Airflow was noticed moving from one zone to another, particularly when some doors were opened, and a significant breeze was felt through the doorway. The airflow between zones is indicative of unbalanced air distribution and ventilation systems which can lead to temperature and humidity control problems, increased energy consumption and poor air quality.

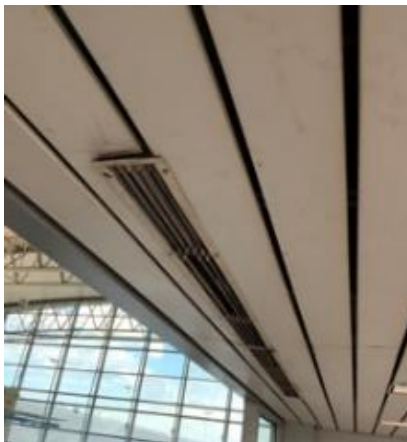
Figure 11.2-2: Representative Door Air Curtain in Terminal Entrance

Terminal and unitary equipment on the apron level is generally found to be in poor condition. This equipment typically has a shorter expected useful life than large central equipment. Located in mostly non-public areas, the terminal equipment on the apron level does not receive the maintenance attention that similar equipment in public areas might receive. Some of this equipment has failed or is operating beyond its expected useful life. Terminal and unitary equipment on the concourse and ticketing level is in better condition than that on the apron level. Door air curtains, shown in **Figure 11.2-2**, are typically functional but in poor condition. Computer room air conditioners (CRAC) located in IT and communication rooms are typically in good condition, but there is no redundancy for cooling in these critical rooms.

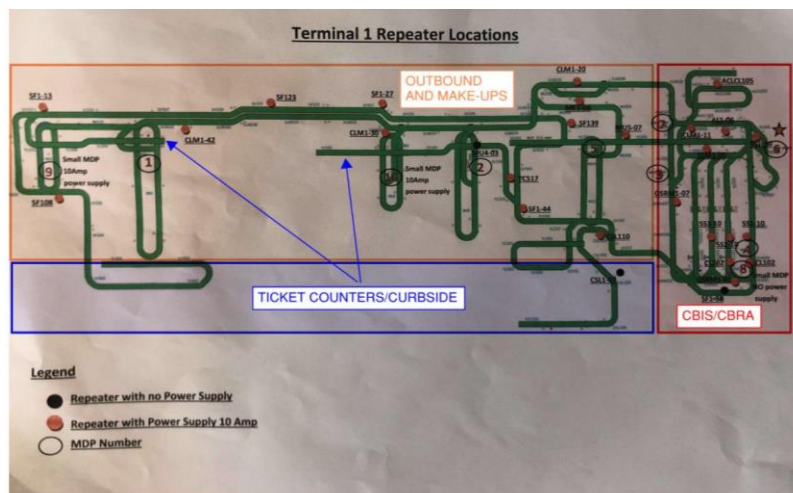
Figure 11.2-5: T1 Vanderlande Baggage System HMI

Of the approximate 480 conveyors, roughly 91 percent of those are rated as “Good” (4). Only about 9 percent of the system is rated as “Fair” (3), and none of the system has an “Unsatisfactory” (1) rating. There are a few instances where conveyors behind locked doors and areas with no catwalk that are accessible; therefore, no rating is given. In addition to the 1-5 ratings, safety issues and preventative maintenance requirements were assessed. **Figure 11.2-6** provides a summary snapshot of the T1 system from the Baggage Inspection and Tracking System BITS™ software program:

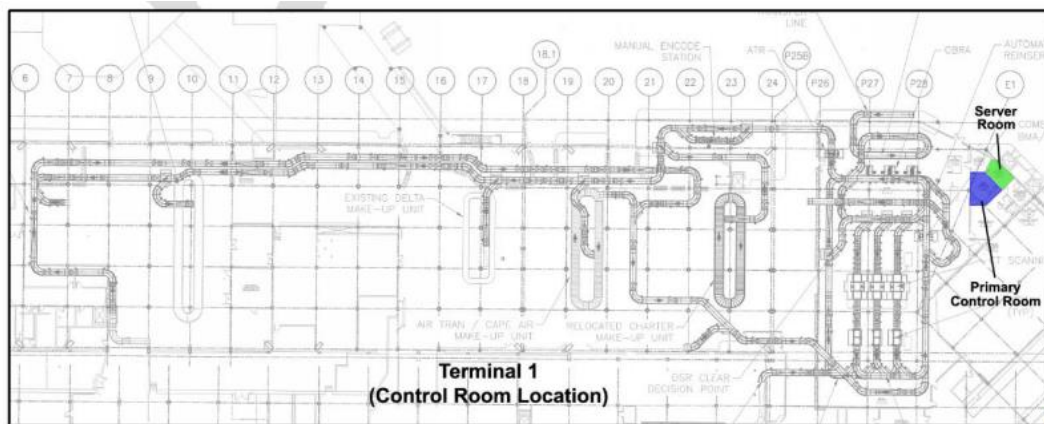
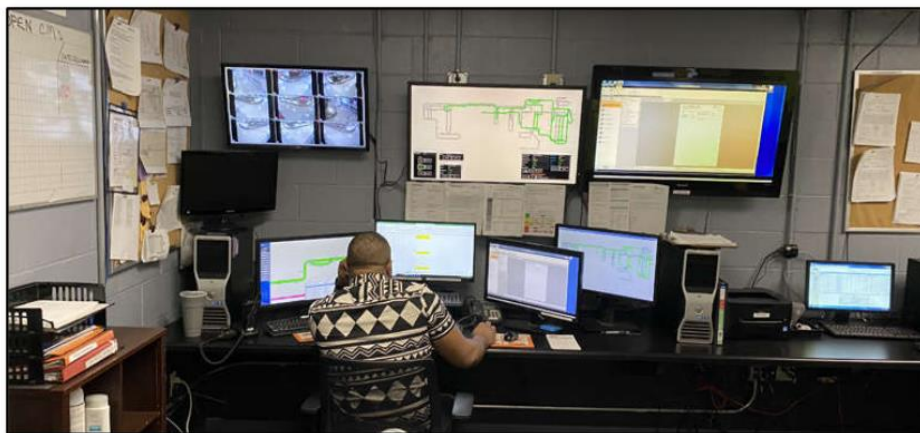
The control room at T1 is the primary control room for dispatching bag jammers and maintenance personnel for both T1 and T2. VI has installed a monitor which replicates the T2 graphics screens and reports. The T1 control room, illustrated in **Figure 11.2-11** and **Figure 11.2-12**, is relatively clean, quiet, and organized. A separate server room, with a climate-controlled temperature of 62 degrees, houses the server and PLC cabinets. This room is clean, well-lit and organized with direct access to all the equipment. The server room is also outfitted with a “dry” fire suppression system.

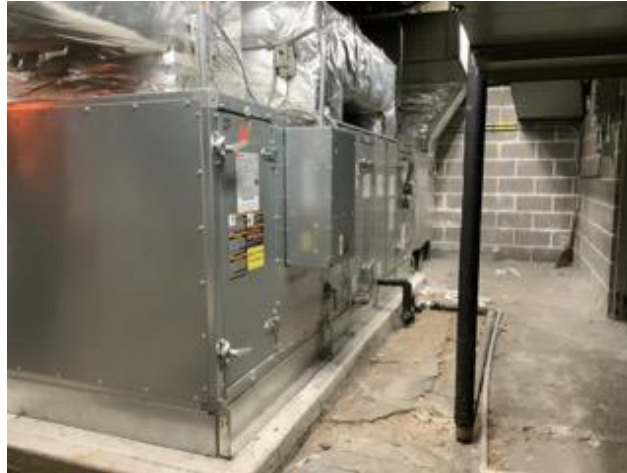
Figure 11.2-13: Typical Newer Indoor Modular Air Handling Unit

In Concourse A, indoor central station air handling equipment is located on the apron level, and rooftop air handlers serve the concourse level. The air handlers (AHU) and rooftop units (RTU) typically have steam and chilled water coils for heating and cooling. The indoor air handlers, most of which are modular air handlers installed in approximately 2008, are in good condition as shown in **Figure 11.2-13**. Rooftop air conditioners and exhaust fans were reportedly installed in 2008 and are also in good condition.

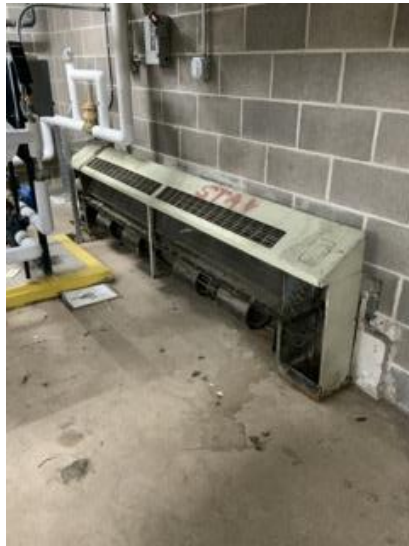
Figure 11.2-14: Fan-Coil Unit Representative of Apron Level Terminal Equipment

Terminal and unitary equipment on the apron level is found to be generally in poor condition. This equipment typically has a shorter expected useful life than large central equipment. Located in mostly non-public and service areas, the terminal equipment on the apron level does not receive the maintenance attention that similar equipment in public areas might receive. Some of this equipment has failed or is operating beyond its expected useful life. Convectors in mechanical rooms and fan coil units in unused service areas are either badly damaged or non-functional, as illustrated in **Figure 11.2-14**. Computer room air conditioners (CRAC) located in IT and communication rooms are typically in good condition, but there is no redundancy for cooling in these critical rooms.

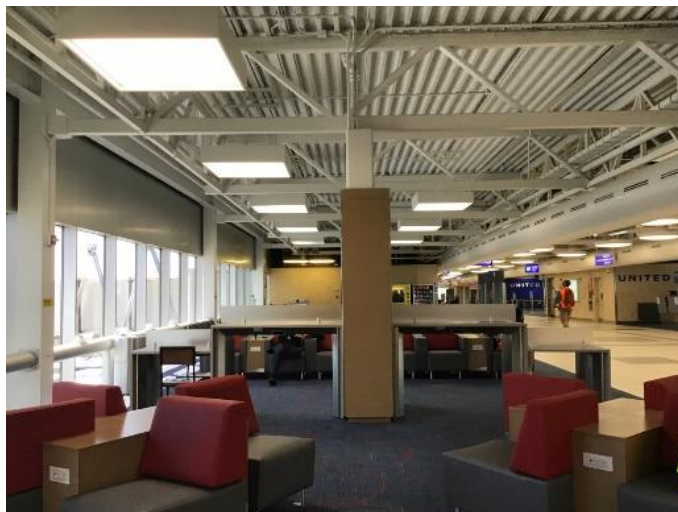
Figure 11.2-15: Concourse A Lighting

The observable conduit and wire distribution system is in fair condition. Generally, conduit and wire installed above ground in dry non-corrosive environments will function indefinitely if not subjected to damage or overloads.

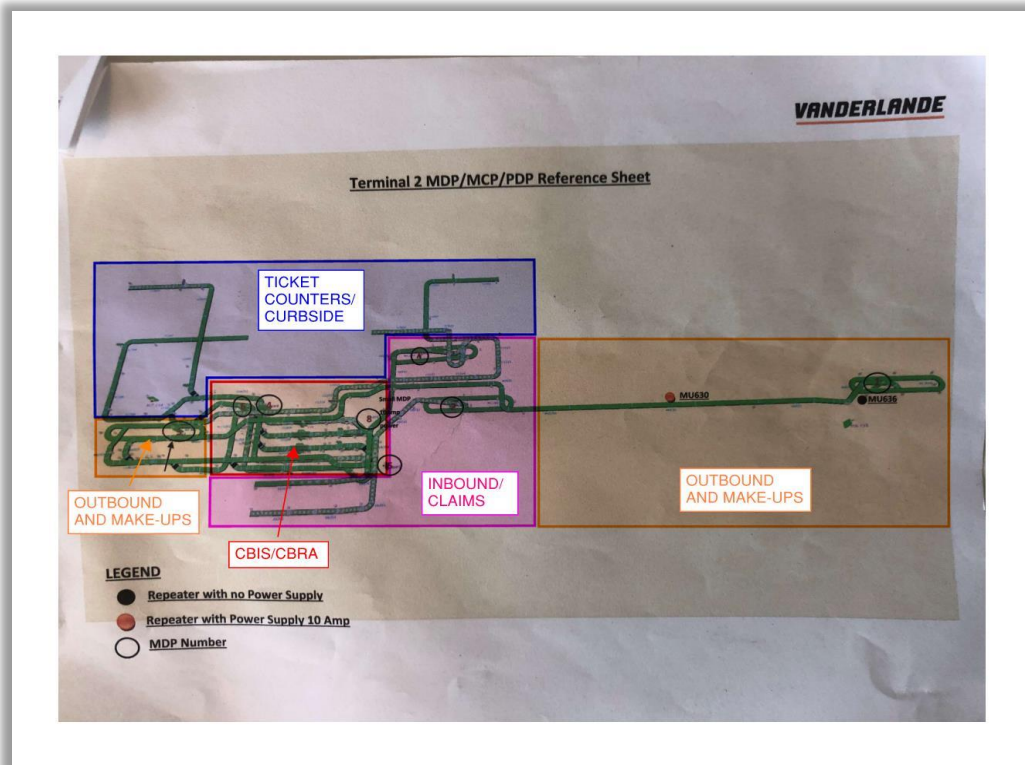
Figure 11.2-17: T2 Baggage System HMI

Of the approximate 320 conveyors, roughly 77% of those are rated as “Good” (4). Still, only about 18% of the system is rated as “Fair” (3). However, there were 13 conveyors and/or MCPs that are assessed as “Unsatisfactory” (1). There are a few instances where conveyors behind locked doors are not accessible and areas with no catwalk and therefore no rating is given. Any safety issues and any preventative maintenance requirements are also noted. **Figure 11.2-18** provides a summary snapshot of the T2 system from the proprietary BITS™ software program:

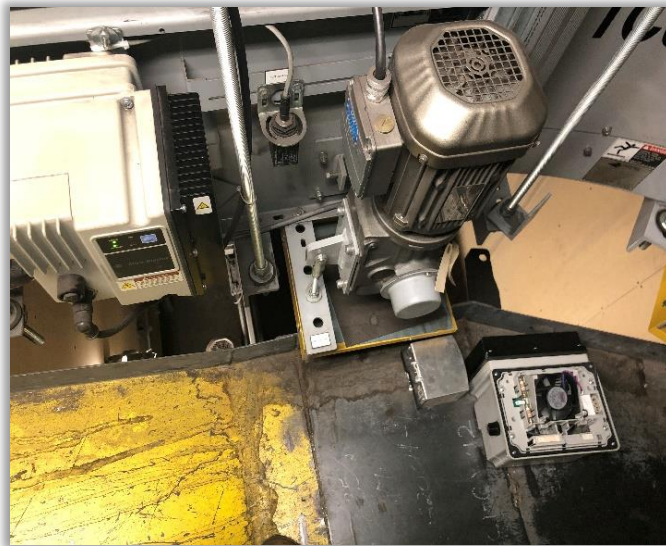
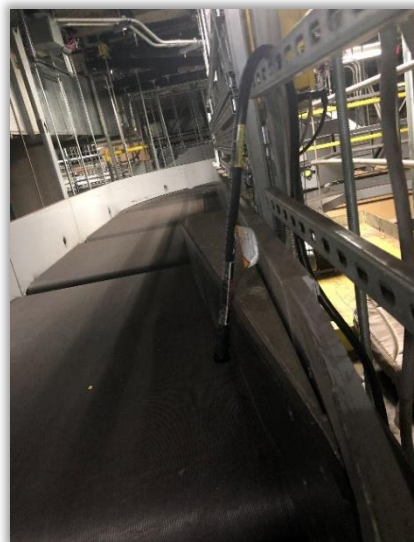
The entire “TC6” ticket counter line illustrated in **Figure 11.2-23** and **Figure 11.2-24** (west side of Terminal 2) is completely shut off. Vanderlande was in the process of repairing several components along that line. Since there is no airline operating out of that side today, it is not an immediate problem. However, that could change very quickly with a new tenant. The majority of the “Unsatisfactory” ratings come from this conveyor line since it is not functioning at this time.

The T2 system is in slightly worse condition than T1, but it is still in good condition and within industry standards. Vanderlande appears to be maintaining the system well and therefore shall have a longer remaining useful life. It is recommended to address the safety and more critical shutdowns mentioned above as soon as possible. The safety issues were also pointed out to Vanderlande managers during the assessment and are aware of these items. It is recommended to continue with routine maintenance. In summary, the remaining useful life of the T2 system is estimated between 8 to 12 years.

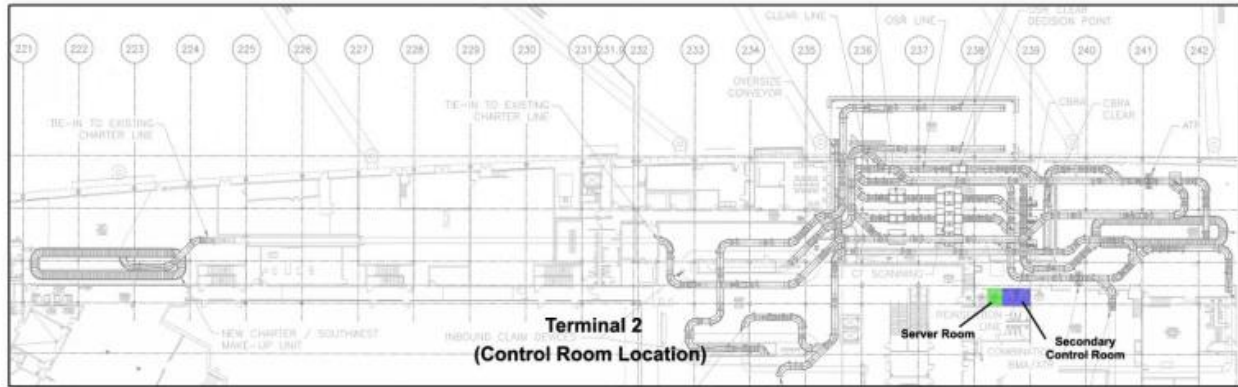
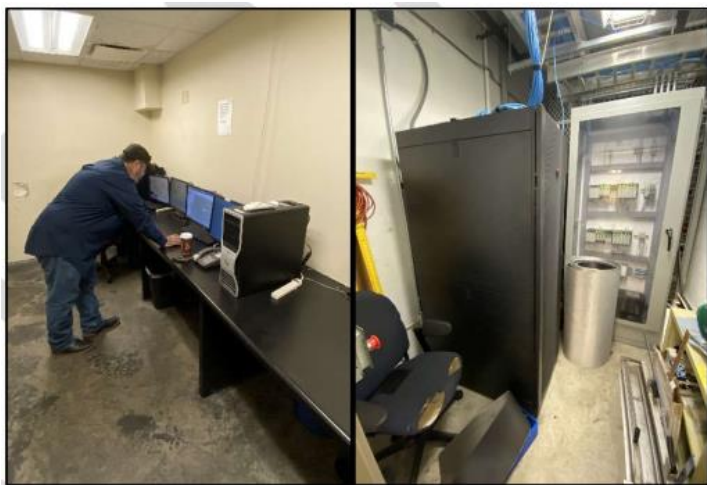
The control room in T2, shown in **Figure 11.2-25** and **Figure 11.2-26**, is roughly half of the size of the T1 control room and is used as a remote/secondary control room. This control room is typically un-manned. The equipment types and models in the T2 control and server room are the same as the equipment in T1. Vanderlande management will access the workstations to reset the screen on the T1 control room from time to time.

The network cables in the T2 server room cabinet are not as organized in the T1 cabinet, however labeling and access for troubleshooting is manageable. The T2-HLC-WS monitor is cracked leaving the right edge of the screen distorted.

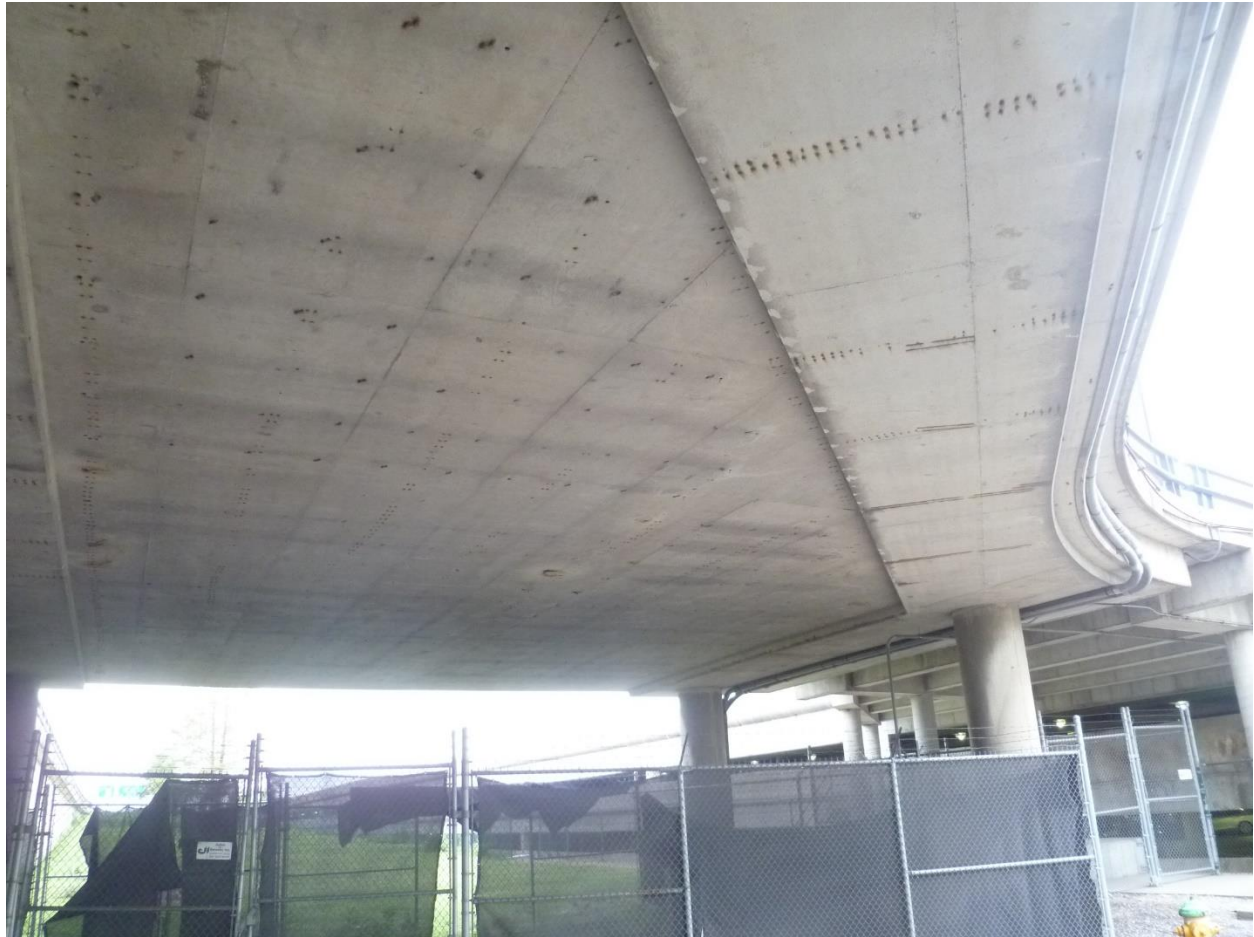
Figure 11.2-40: Underside of LIB to Terminal 1 Garage Bridge superstructure

The LIB to Terminal 1 Garage Bridge illustrated in **Figure 11.2-40**, which is adjacent to and abuts the LIB Bridge over Airflight Drive, carries traffic from LIB into the top (brown) level of the Terminal 1 parking garage. This bridge was presumably built at the same time as the parking garage. The bridge is a two-span structure with a flat slab span adjacent to LIB and a cast-in-place concrete girder span adjacent to the parking garage. The two end bents and the intermediate bent are on columns with unknown foundations.

This bridge, because of its proximity to the LIB over Airflight Drive Bridge, is typically rehabilitated together with the LIB over Airflight Drive Bridge. The joints on this bridge were replaced recently and an overlay was applied at the same time as the recent rehabilitation of the LIB Bridge over Airflight Drive. No significant deterioration is evident.

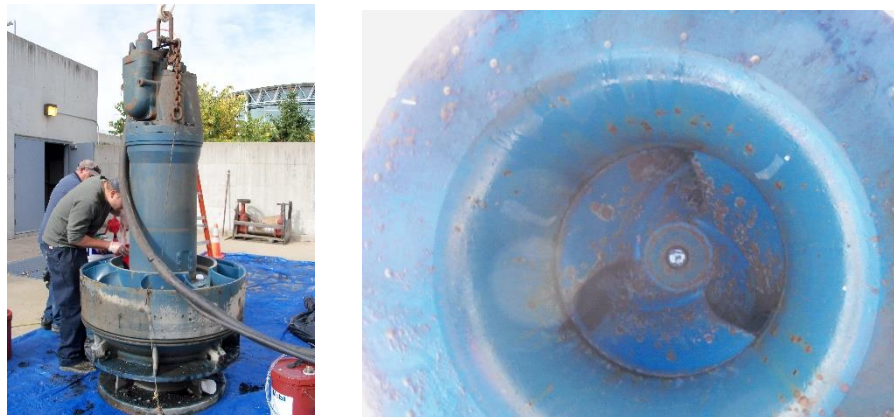
Figure 11.2-42: Primary Stormwater Pumps and Impeller (Per Previous Inspection by Others)

The primary stormwater pumps are 22 years old and only have 3.5 hours of run time over the 22-year life. The limited amount of pump run times are assumed to be maintenance run time, though technical experts for the Airport state the pump station operated to prevent flooding during a storm event following the pump station coming online.

The remaining useful life of the dewatering pump is 1-5 years based on information provided that the pump is 22 years old and needed to be rebuilt in 2010. A spare pump is stored on site.
